Manhole Inspection Summary

Manhole # S51M__020MH

Insp Date: **4/11/08 9:22 AM**

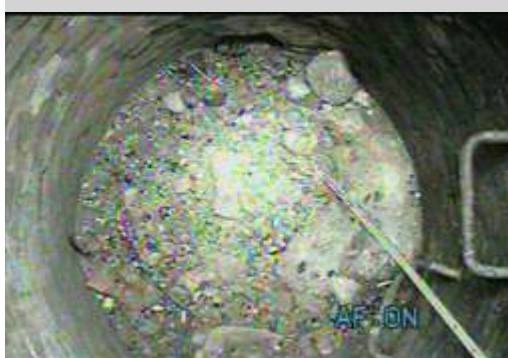
Defect 3

Condition: ☐ Sound ☐ Cracked ☐ Root Intrusion ☐ Deteriorated ☐ Leaks ☒ **Debris**

channel debris

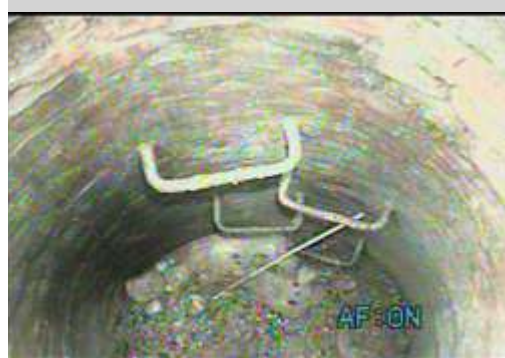
Defect 2

Steps Count: **4** Missing: **0** ☒ **Corroded**

corroded stairs

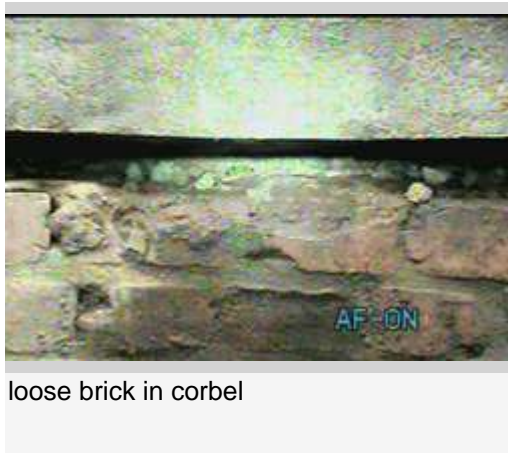
Defect 1

Condition: ☐ Sound ☐ Cracked ☐ Root Intrusion ☒ **Loose Brick** ☐ Deteriorated

loose brick in corbel

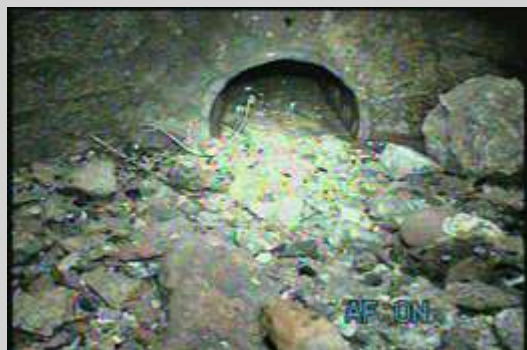
12 O'Clock Outflow

8 in. Circular Gravity Sewer
Pipe Out @ 12 O'Clock

Deposits: ☐ None ☐ Mud ☒ **Gravy** ☒ **Debris** ☐ Grease

Silt Depth: **3** (in.) Deposits Extent: **Medium**
